Report on Stream Health in Montgomery County, Maryland 2010-2015

ANS Water Quality Monitoring Program

Executive Summary

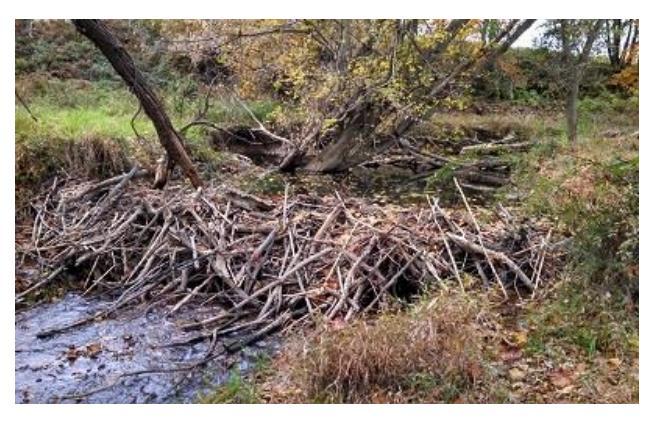
The Audubon Naturalist Society has another site on the Rock Creek mainstem at the Agricultural History Farm Park. It, too, has achieved good and excellent ratings at times, but was only fair in 2015. The site is bordered by a narrow strip of trees surrounded by lawn on one side and crops on the other. Fallen riparian trees caused loss of shading in summer 2012. Then, clearing of invasive plants by park personnel in 2014 left large stretches of the banks bare of vegetation. That same year, a beaver moved in and dammed the creek.

Beaver Dam on Rock Creek at the Agricultural History Farm Park

We recommend installing streambank protection following removal of invasive plants, so that runoff does not impair the banks further. In addition, the stream in this location would benefit from a wider riparian buffer. We recommend planting native trees and shrubs on both banks to achieve the buffer widths recommended in the County's Environmental Guidelines.

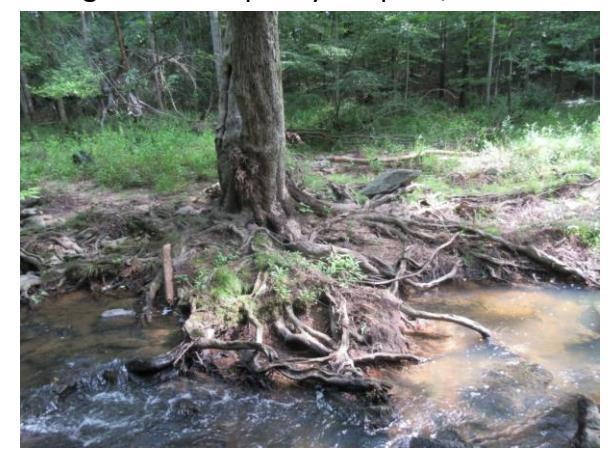
Top soil washed away and tree roots exposed by flooding in 2014 on the North Branch of Rock Creek at Kengla Conference Center

Water quality improved to "good" in 2010, but declined to "fair" in 2015 following floods and sewer reconstruction by WSSC in the floodplain the summer year before. During floods, topsoil was washed away, a bank with several trees collapsed, and sewer construction materials were swept into a logjam that stretched across the stream. This site appears to be highly responsive to construction within the watershed. It remains to be seen whether water quality here will rebound following completion of the sewer reconstruction.

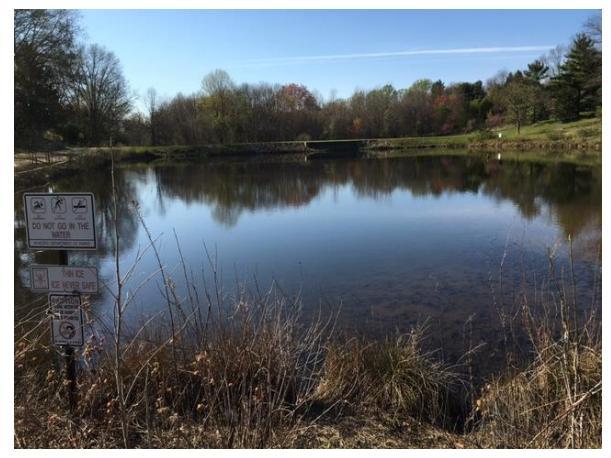
Although DEP gives the Upper Mainstem of Paint Branch a "good" rating, the ANS site has consistently rated "poor". In the last few years ANS monitors have found very few macroinvertebrates, almost all tolerant to pollution. On occasion, baseflow is so low that the stream cannot be monitored. We recommend inspection of the stormwater pond to determine

Countryside stormwater pond

whether it is still functioning properly and remediation of outdated stormwater controls on Briggs Chaney Road and in the subdivision.

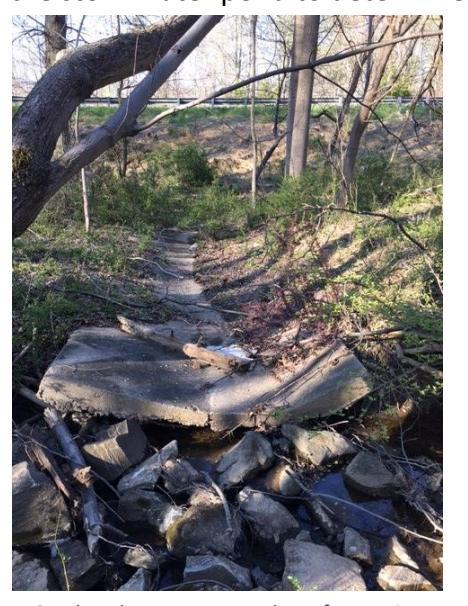
Outdated stormwater culvert from Briggs Chaney Road to Countryside Tributary

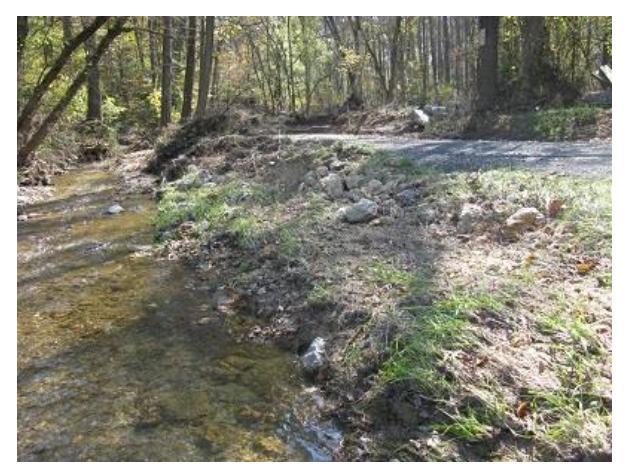
ANS teams have monitored the unnamed tributary adjacent to West Old Baltimore Road since 1997. This site is downstream of DEP's monitoring station LSTM204. It is partly within a pasture and partly within a small wooded area. In early 2011, MCDOT widened West Old Baltimore Road, cutting into an old berm that separated it from the stream. In September of that year, floods from Tropical Storm Lee washed away much of the rest of the berm. Now the stream flows over the road when it floods, and runoff from the road washes into the stream during average rain events. We recommend evaluating whether to reconstruct the berm.

Only a few stones remain from a berm that separated West Old Baltimore Road from Ten Mile Creek until 2011

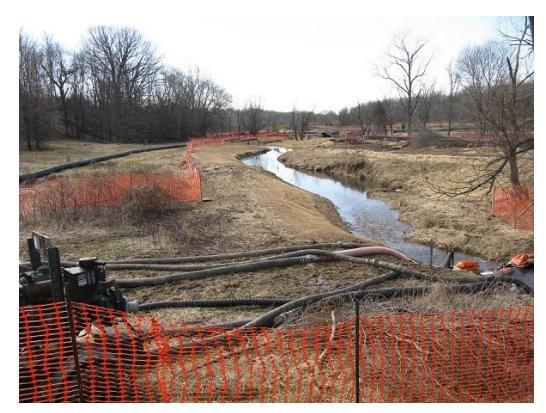
Goshen Branch was restored between fall 2011 and summer 2012 under ICC Compensatory Mitigation Project SC-2. Subsequently, water quality declined from "good" in 2010 to "poor" in 2013-2015. Coastal Resources, Inc., which has been monitoring Goshen Branch for the State Highway Administration, has also found negative change in the rating for benthic macroinvertebrates. In a paper delivered at the Maryland Water Monitoring Council's Annual Conference on November 13, 2015, Sean Sipple of Coastal Resources also noted a change in functional feeding groups of the benthic community from scrapers to filterers. *See* <u>http://www.dnr.maryland.gov/streams/MWMC/pdfs/2015_Conference/Sipple_Presentation_fi</u> nalSean.pdf.

ANS data shows this, as well. At site visits since restoration, the ANS team has also found an increase in algae and fine sediment deposition along the entire reach. In fall 2013, a beaver built a dam at the top of the reach and appeared to have cut down trees planted for the restoration. The beaver abandoned the dam by spring 2014. Trees replanted since then seem to be surviving. We will continue to study Goshen Branch to determine the cause(s) of the negative change and to see if water quality improves.

Restoring Goshen Branch

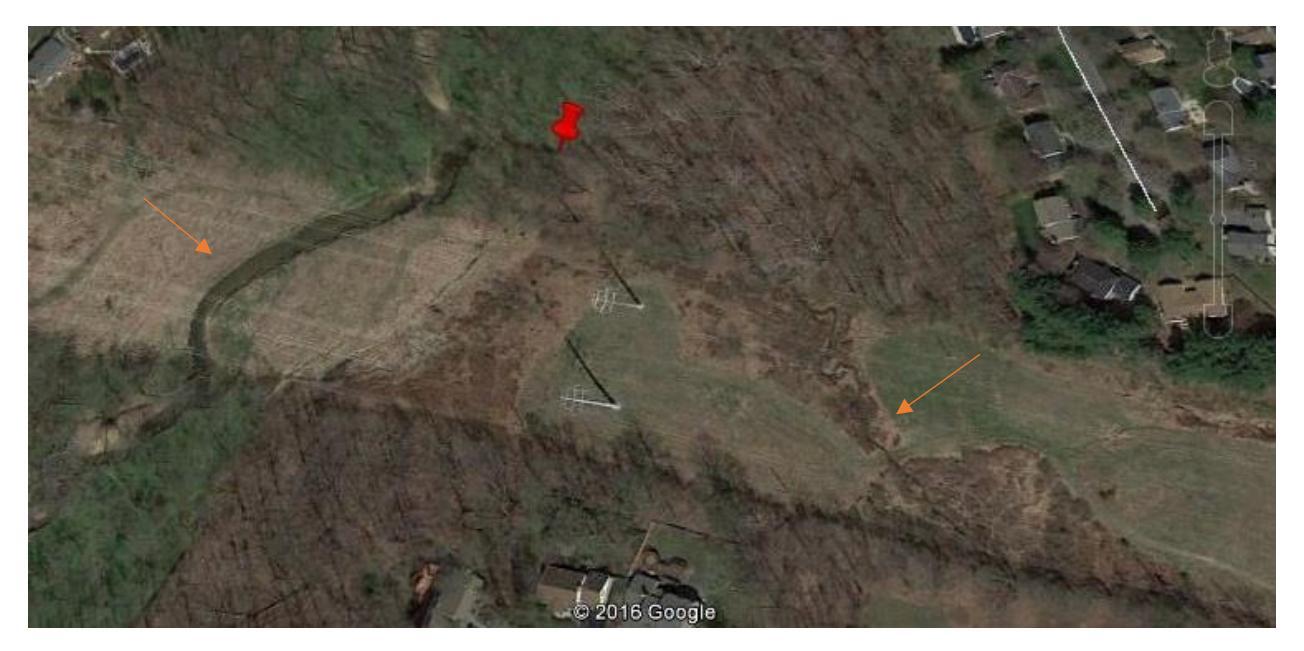
One of the goals of the project is to reestablish a riparian buffer within the restoration area. The benefits of restoration upstream may not be realized downstream unless a vegetated corridor is also installed in the powerline cut to connect the restored segment with the rest of the tributary. A riparian buffer of small trees and shrubs in the powerline cut would reduce the volume and velocity of runoff from the powerline cut; it would moderate water temperatures; and it would provide more favorable habitat for aquatic life. To do so would mean ceasing mowing near the stream and planting a riparian buffer of native shrubs and small trees in an area that meets or exceeds the County's Environmental Guidelines for stream buffers. The same technique should be applied to the mainstem of Watts Branch, which has become severely eroded. The picture below shows that it, too, lacks protective riparian vegetation.

ANS monitoring site on Fallsreach Tributary, showing the powerline cut with Watts Branch on the left and Fallsreach Tributary on the right

Planting native shrubs within powerline cuts has been used at the Patuxent Wildlife Refuge, leading to increased species diversity. The US Fish and Wildlife Service recommends that this technique be adopted throughout the nation.

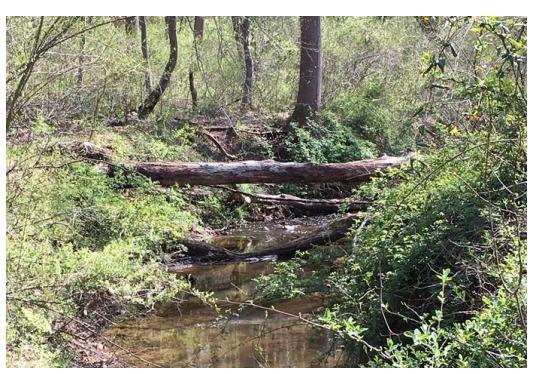
Between 1995 and 2010, the Audubon Naturalist Society monitored Gunner's Branch just downstream of Gunner's Lake and the railroad crossing. Heavy runoff from the lake had so incised the stream and undercut massive trees that the site had to be abandoned after the 2010 season. The vertical banks were as high as the monitors were tall, and the fallen trees required climbing into and out of the stream at several locations, which was hard for them to do. Water quality was

Gunner's Branch downstream of Gunner's Lake

consistently poor, as compared to DEP's rating of "fair" for the entire watershed. We recommend that this location be evaluated for streambank protection.

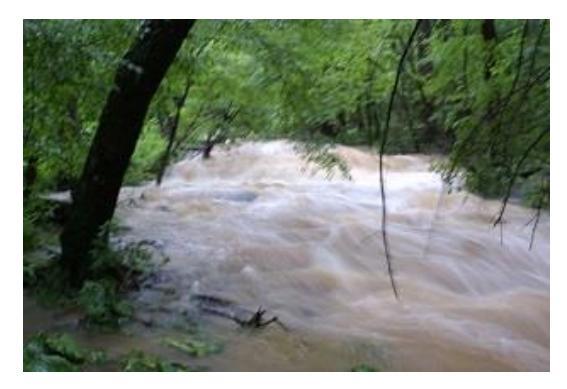
The ANS monitoring site on Dayspring Creek is downstream of a dry stormwater pond built in the mid-1990s to serve the Seneca Crossing subdivision, a residential community of 450 units. On occasion, the stormwater pond exceeds its capacity during storms and causes flooding downstream. This pond should be evaluated for an increase in storage capacity.

Overflow on Dayspring Creek from Seneca Crossing Stormwater pond upstream

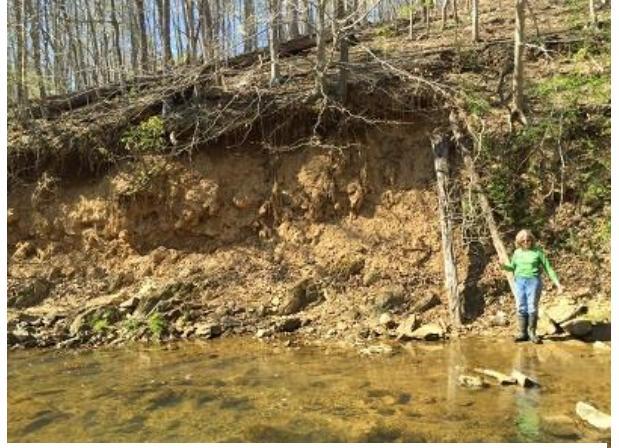
Storm Lee in 2011; Hurricane Sandy in 2012; and several short, but intense storms in 2013 and again in late spring and summer 2014. ANS teams throughout the County noted significant changes to their streams as a result. Erosion from high flows can be so severe that banks collapse, riparian trees are undercut and fall, stream channels change, and point bars are enlarged. Streambank erosion on many third and fourth order streams is particularly severe. At Watts Branch in Potomac, shown on the right, mean bank

Streambank erosion at Watts Branch in Potomac

erosion is estimated to be seven meters high. Erosion on the right bank of Muddy Branch is now two meters high.

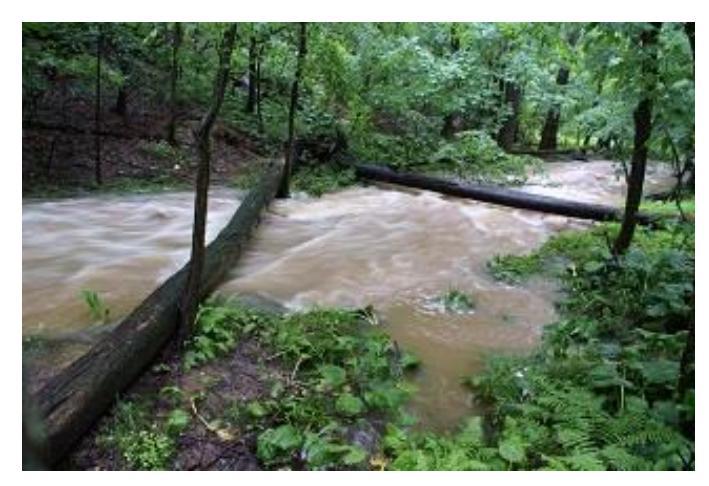
Trees felled by high runoff

Another striking change has been loss of riparian trees. In addition to the trees brought down at Gunner's Branch by high flows from Gunner's Lake, successive storms between 2011 and 2014 washed out all riparian trees on Great Seneca Creek upstream of Riffle Ford Road. By fall 2015, there were no longer any trees within 15 feet of the banks. At Watts Branch in Potomac, the largest fallen trees can be seen in satellite images. Twenty more trees are expected to fall soon at this location.

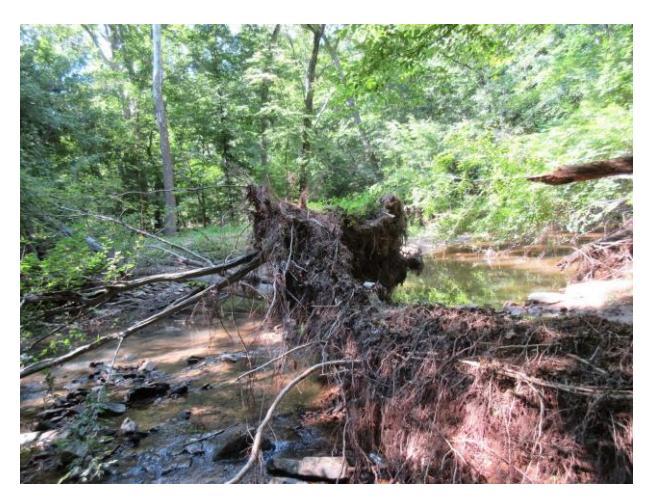
On the North Branch of Rock Creek at Kengla Conference Center, a bank downstream of the monitoring site collapsed in summer 2014.

Collapsed bank on the North Branch of Rock Creek, Derwood

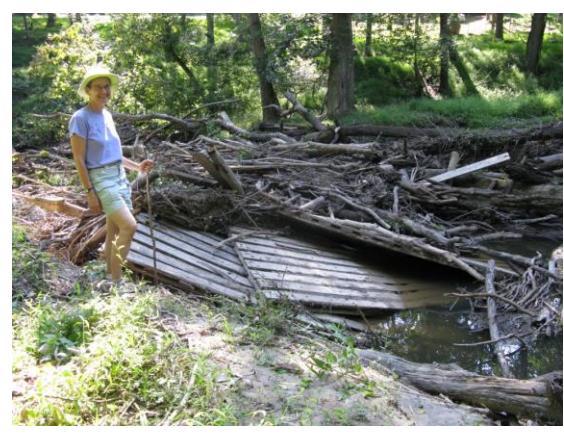
We recommend frequent inspection of sewer reconstruction sites. In summer 2014, when sewers along the North Branch of Rock Creek were being reconstructed, construction debris and trees cut down for the construction access road were allowed to wash into the stream.

They formed a logjam, which caused flooding during storms. Monitors also observed heavy equipment operating without mandatory silt fencing along the bank.

Logjam of construction materials and tree trimmings from reconstruction of sanitary sewers on the North Branch of Rock Creek at Kengla Conference Center

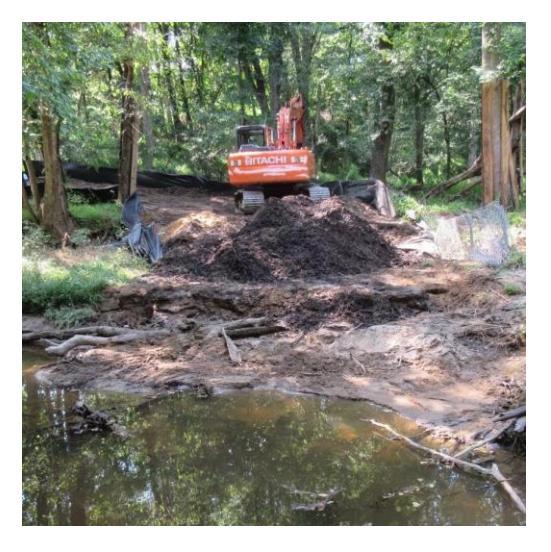
Heavy equipment operating without mandatory silt fencing during sewer reconstruction on the North Branch of Rock Creek

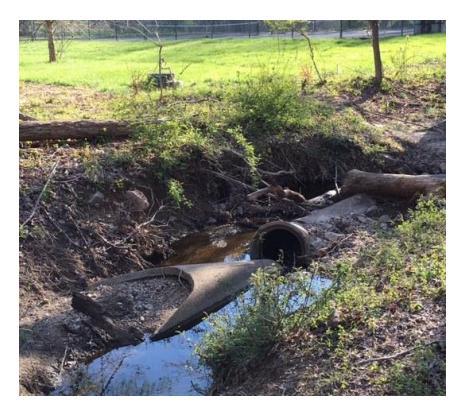
Exposed and broken sewer pipes at Countryside Tributary

On the Countryside Tributary of Paint Branch, monitors discovered exposed and broken sewer pipes in the stream. They should be inspected to determine whether any discharge is flowing into the stream. If they are no longer in use, they should be removed.
