Report on Stream Health in Montgomery County, Maryland 2010-2015

ANS Water Quality Monitoring Program

Executive Summary

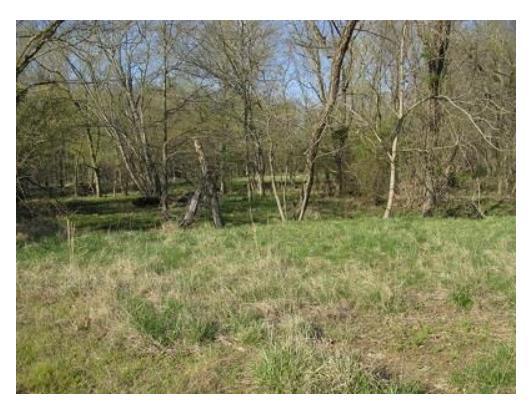
One success story is the improving water quality of the Rock Creek mainstem upstream of Muncaster Mill Road. The surrounding area is a natural, undisturbed valley of trees and old fields. ANS data shows improving water quality from fair in springs 2005-2008, to good in springs 2009-2013, and to excellent in springs 2014-2015. DEP also has found this "Fraley Farm Mainstem" to have excellent water quality.

Mainstem of Rock Creek upstream of Muncaster Mill Road

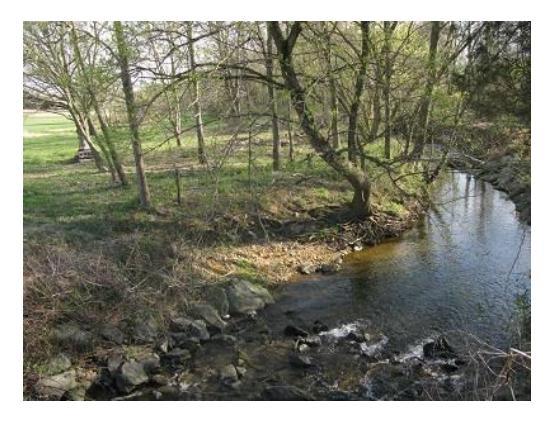
The Audubon Naturalist Society has another site on the Rock Creek mainstem at the Agricultural History Farm Park. It, too, has achieved good and excellent ratings at times, but was only fair in 2015. The site is bordered by a narrow strip of trees surrounded by lawn on one side and crops on the other. Fallen riparian trees caused loss of shading in summer 2012. Then, clearing of invasive plants by park personnel in 2014 left large stretches of the banks bare of vegetation. That same year, a beaver moved in and dammed the creek.

ANS site on Rock Creek at the Agricultural History Farm Park

We recommend installing streambank protection following removal of invasive plants, so that runoff does not impair the banks further. In addition, the stream in this location would benefit from a wider riparian buffer. We recommend planting native trees and shrubs on both banks to achieve the buffer widths recommended in the County's Environmental Guidelines.

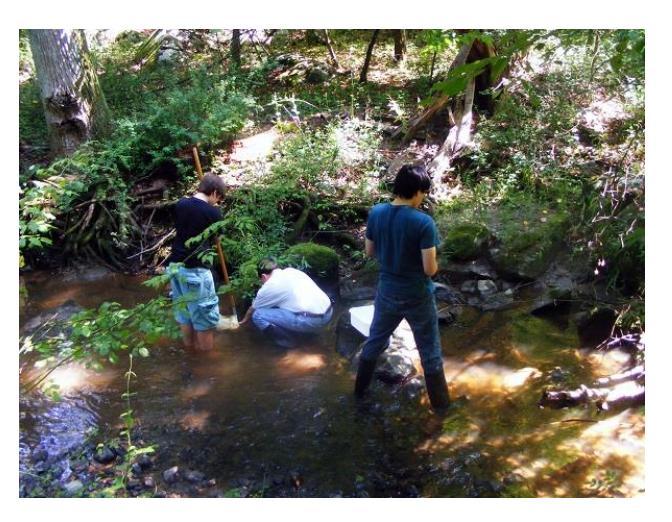
Upstream of Bowie Mill Road, the North Branch itself serves as the boundary of the SPA. On the SPA side of the creek are farms and homes on large lots with an 8% limit on imperviousness. On the other is a residential subdivision of homes on smaller lots with no imperviousness limit. Because only one side of the creek is protected, it does not receive the full benefits of the SPA. As a result, average water quality at the ANS site was only "fair" from 2011-2015, although it rated "good" in spring 2015.

Monitoring the North Branch of Rock Creek at Bowie Mill Road

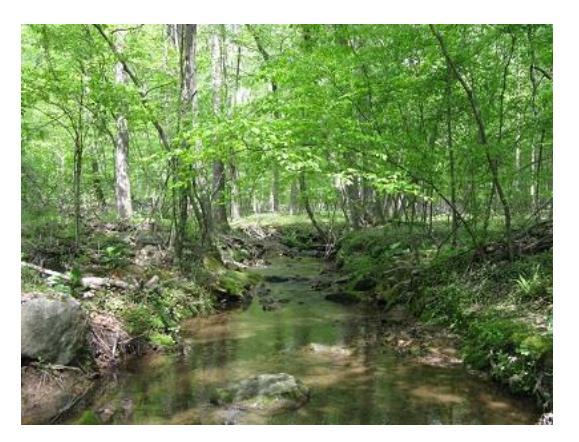
ANS began monitoring the Good Hope Tributary in spring 2011. The site, located in a wooded floodplain dotted with skunk cabbage, is downstream of the ICC. Water quality ranged from "good" in spring 2011 to "fair" in spring 2015.

Good Hope Tributary of Paint Branch

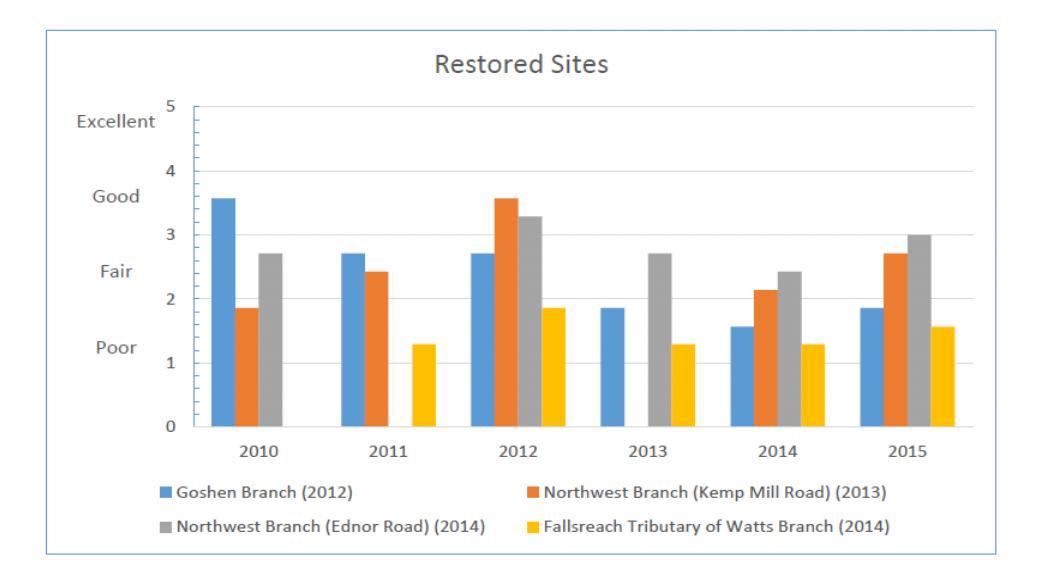
Several of the streams we monitor were restored between 2010 and 2015. Restoration has had mixed results, as can be seen in this chart. Water quality at some of the streams has stayed generally within the same range. At Goshen Branch, though, it has declined.

Goshen Branch was restored between fall 2011 and summer 2012 under ICC Compensatory Mitigation Project SC-2. Subsequently, water quality declined from "good" in 2010 to "poor" in 2013-2015. Coastal Resources, Inc., which has been monitoring Goshen Branch for the State Highway Administration, has also found negative change in the rating for benthic macroinvertebrates. In a paper delivered at the Maryland Water Monitoring Council's Annual Conference on November 13, 2015, Sean Sipple of Coastal Resources also noted a change in functional feeding groups of the benthic community from scrapers to filterers. *See* <u>http://www.dnr.maryland.gov/streams/MWMC/pdfs/2015_Conference/Sipple_Presentation_fi</u> nalSean.pdf.

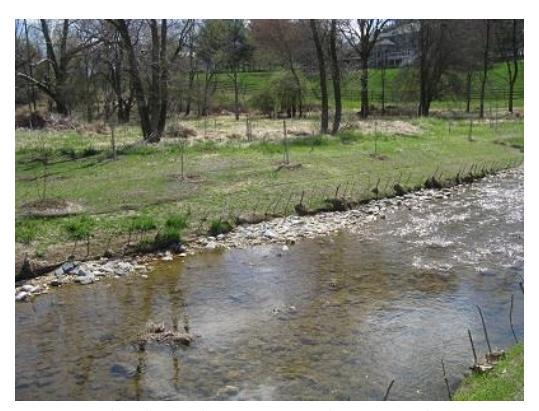
ANS data shows this, as well. At site visits since restoration, the ANS team has also found an increase in algae and fine sediment deposition along the entire reach. In fall 2013, a beaver built a dam at the top of the reach and appeared to have cut down trees planted for the restoration. The beaver abandoned the dam by spring 2014. Trees replanted since then seem to be surviving. We will continue to study Goshen Branch to determine the cause(s) of the negative change and to see if water quality improves.

Newly planted trees at Goshen Branch

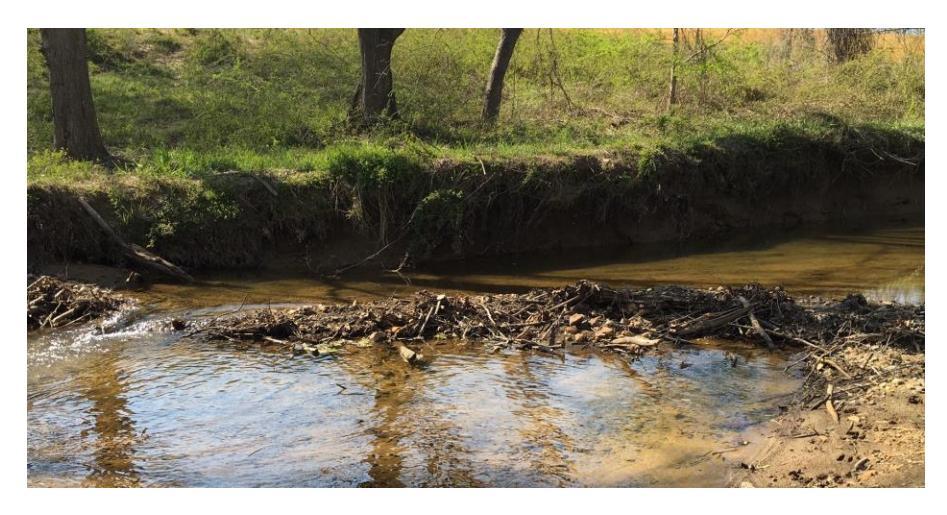
A resurgence of beavers appears to be taking place throughout the county. From 2012 to 2015, monitoring teams at Countryside Tributary of Paint Branch, Northwest Branch, Rock Creek, Goshen Branch, and Bucklodge Branch reported finding beaver activity, from dams to cut-down trees. On Rock Creek at the Agricultural History Farm Park, part of the reach was submerged when a beaver began building a dam. After the team shifted the reach downstream, the beaver built a new dam that again flooded the reach, making it impossible to monitor. In the subdivision adjacent to Countryside Tributary, residents found beaver damage to landscaping trees. The beavers do not seem to stay in the same place for a long period of time. They tend to move away after a year or two.

An abandoned beaver dam
